Remote monitoring data

Remote monitoring sensors were put in at a care home environment due to ongoing out of specification legionella results.

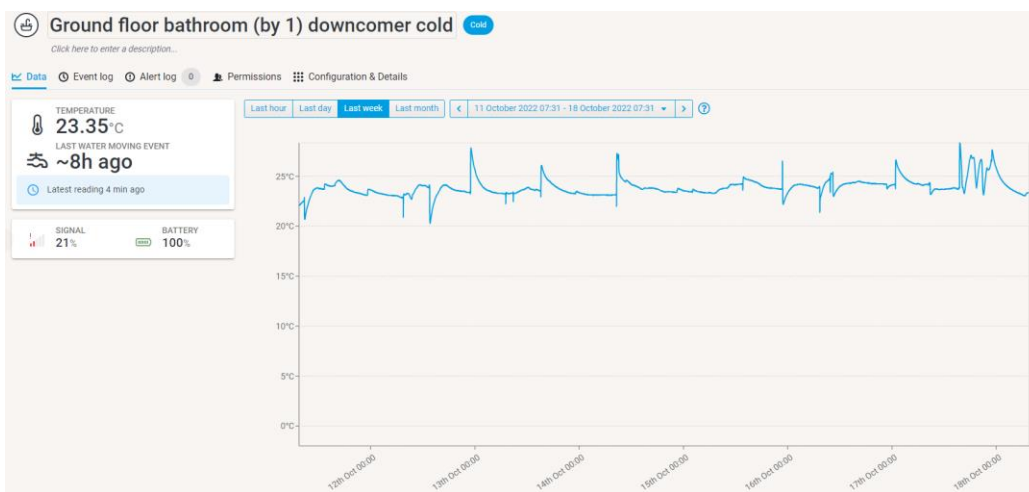
Downcomer by bathroom 1 cold. Clicking on this then shows the data over a longer period of time – as you can see from the graph it is repeatedly not hitting below 20 degrees

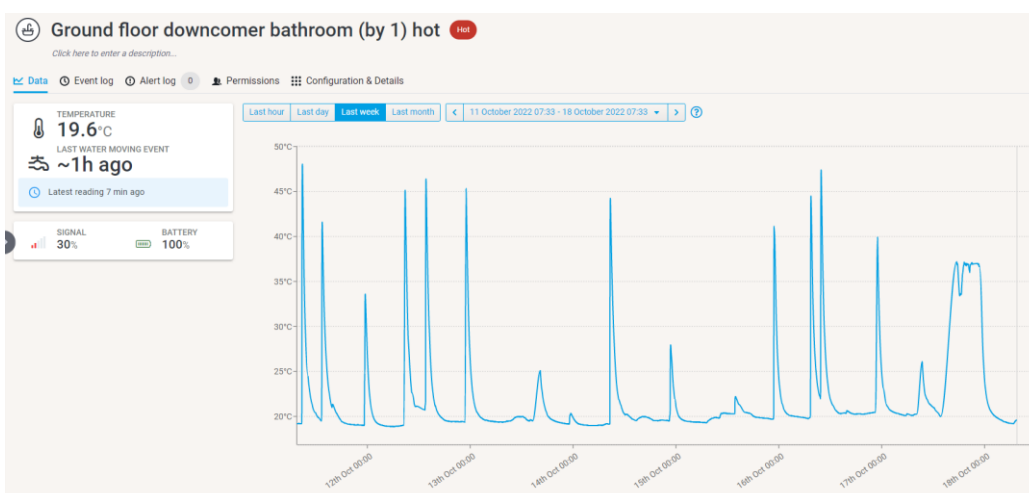
This indicates the downcomer by 1 and room 19 (both on the ends of the system) have failed to hit compliant levels in the last week – ie. see below the downcomer hot

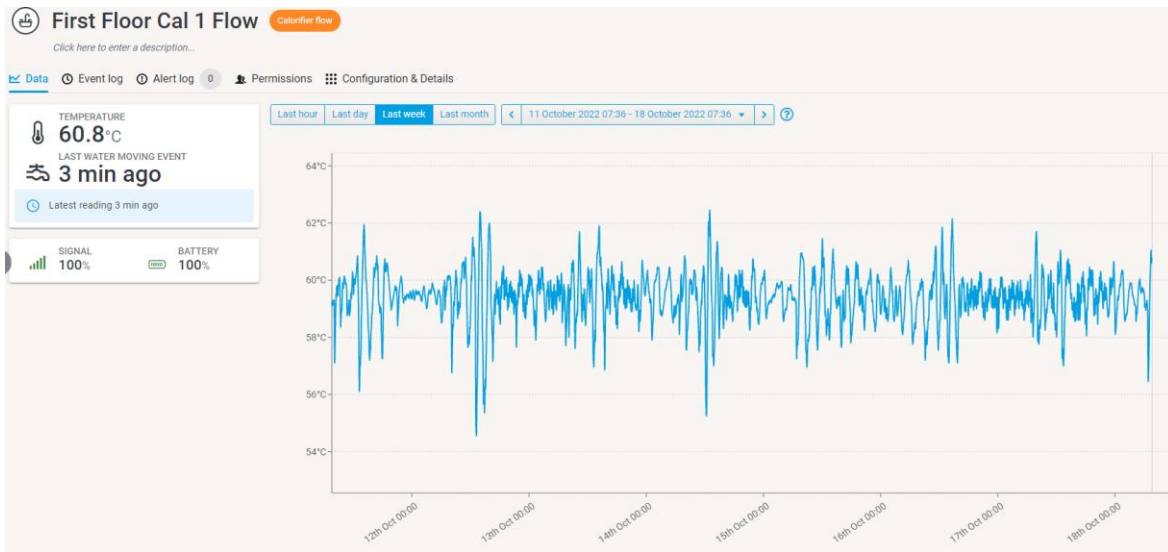
Whilst the calorifier flow temperatures are currently compliant, there have been times where the minimum levels are dipping below 60 degrees on site – see below

- Calorifier temperatures need to rise at source to ensure the flow temperatures are 60 degrees as a minimum
- Extend the flushing period at the outlets to ensure that there is thermal kill via the flushing regime (monitor temperatures as part of this process)
- Review the hot water circulation towards the end of the system with consideration given to reviewing the sizing of the recirculation pump and potential re-balancing
- Insulate the existing pipework to prevent potential heat gain/loss on the pipework. This is particularly prevalent in the boxing on site as well as in the roof space

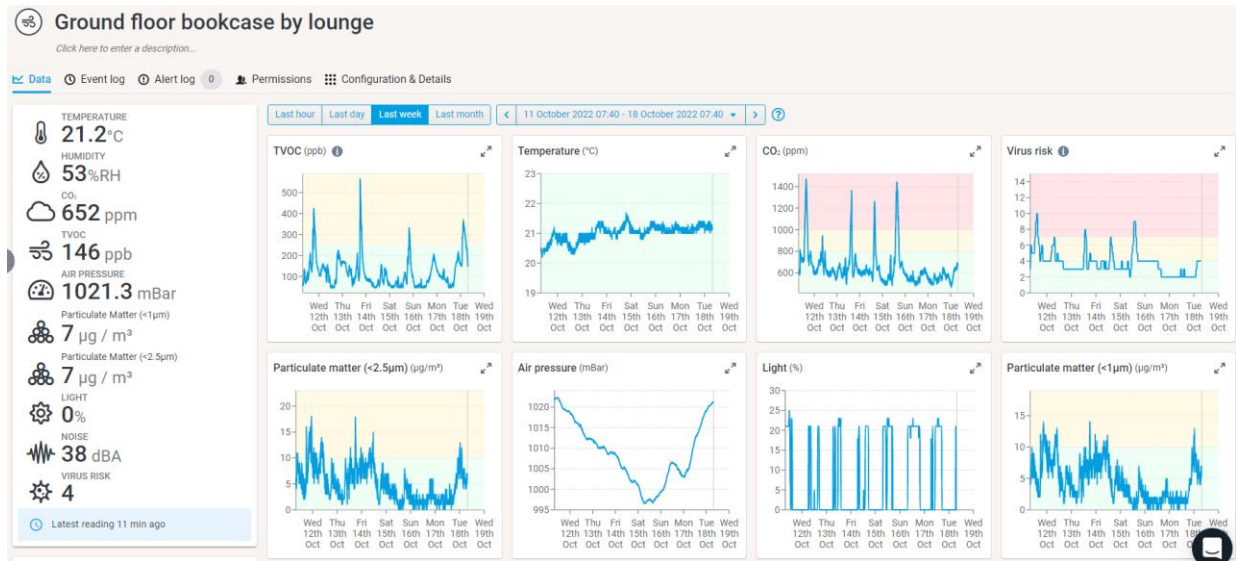
The previous graph is set to an hour, however altering the widget to go over the last week indicates the CO2 level at points exceeded 1400ppm, far exceeding 1000ppm on four separate occasions.

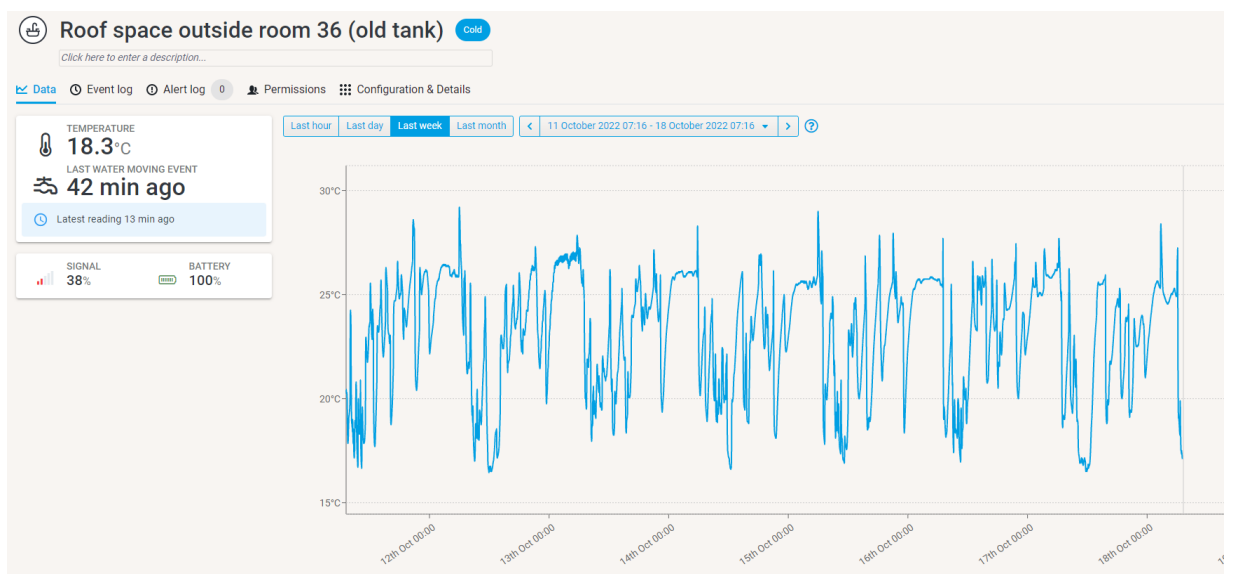
The cold-water pipework feeds up to the roof space on site to then distribute via the old cold water tank network on site. This causes warming of the cold pipework in the roof space – this is not also the height of summer (tested in October) – see below graph on that probe.

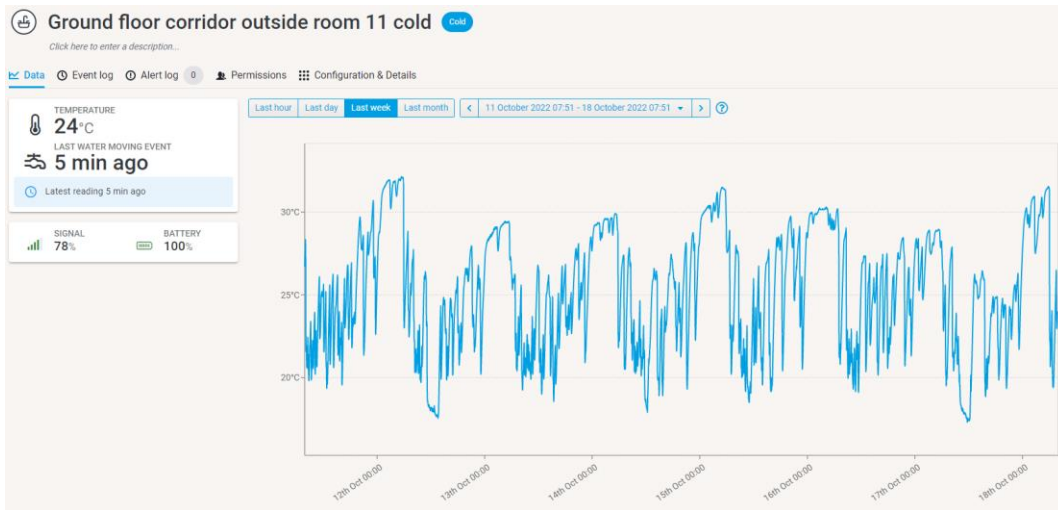
A temperature probe was also placed on the main pipework run on the ground floor that's within the boxing (see picture on the next page) – below indicates the thermal gain occurring on this pipework run.

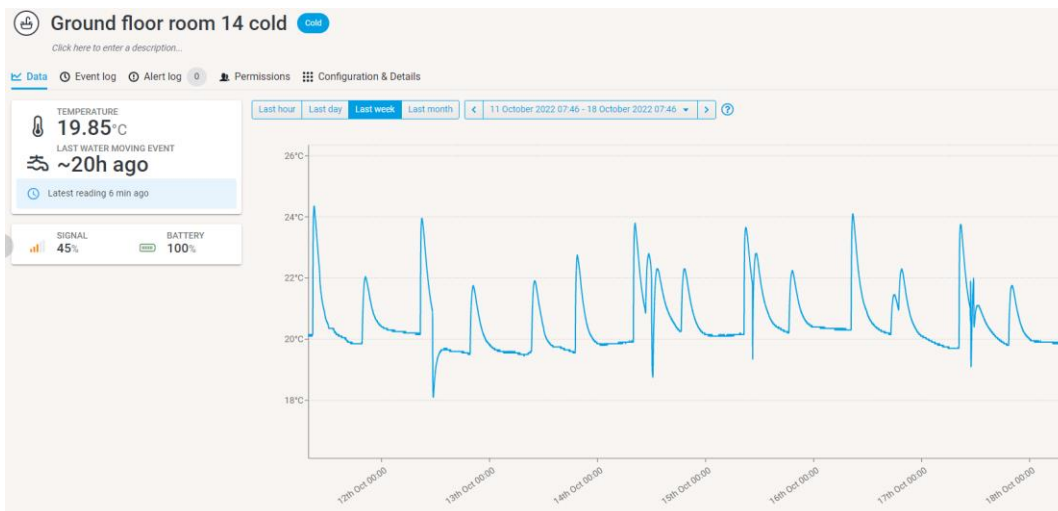
The cold water system temperatures also help indicate the movement through the pipes and vindicate the flushing programme. Below is imagery for room 14, which is under a daily flushing programme at the moment due to ongoing counts. The tap appears to be being opened at multiple times per day, but the graph helps illustrate the limited time the pipework will be sat below 20 degrees (though helps illustrate this is preventing temperatures from increasing to the same levels as the roof space).

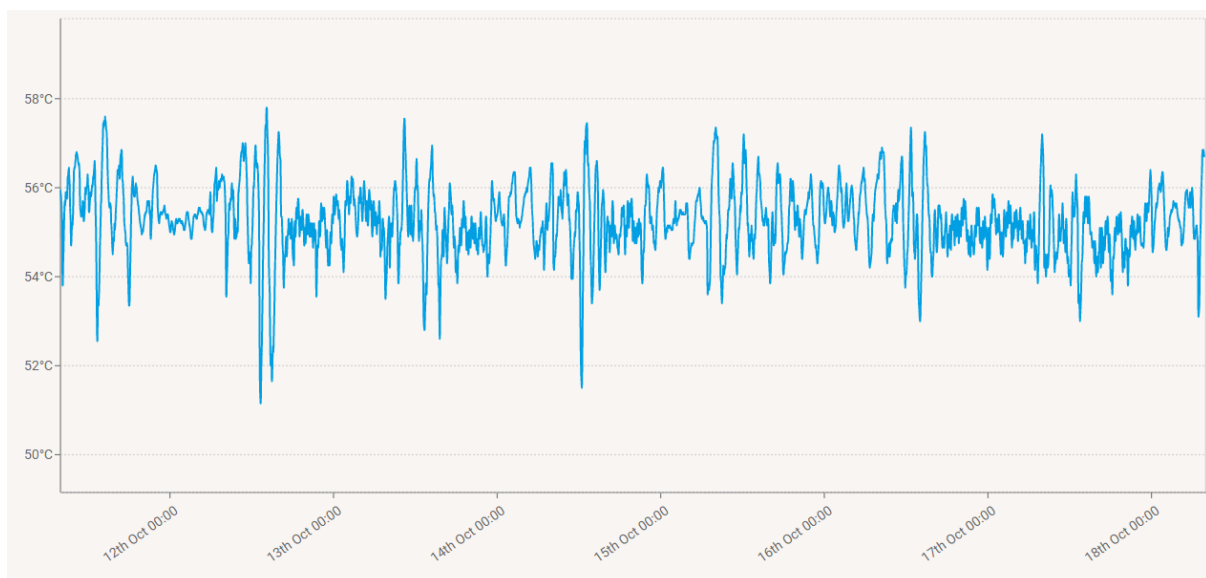
The recirculation pipework temperatures are below, first for the corridor outside room 11 and then also the pipework monitored in the second picture near room 1 (next page). The temperatures in the main pipework run appear to be reaching 55, however they are not staying above this level. The probe by room 1 shows temperatures well below this.

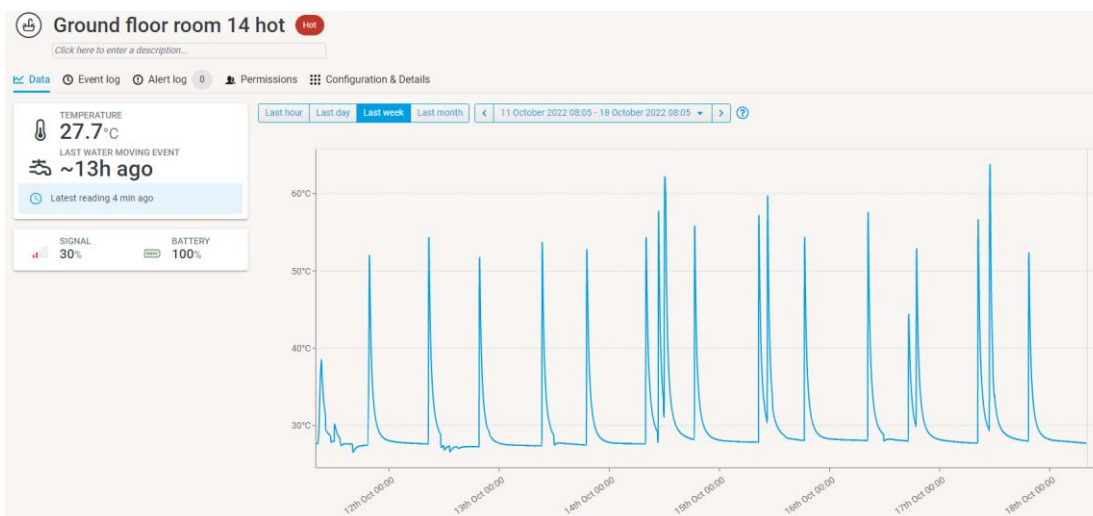
For room 14 – the only location with the outstanding legionella count. The temperatures have recently improved so that during flushing temperatures are at times achieving 60 degrees, however there remains a large amount of time where temperatures sit within the ‘growth zone’. Off the back of this it would be beneficial to ensure that when flushing known areas with bacterial counts, the instruction goes out to ensure that the temperatures are monitored and the flushing period only starts after temperatures are at the point where thermal kill is being achieved.
