Remote monitoring data

Remote monitoring sensors were put in at a care home environment due to ongoing out of specification legionella results.

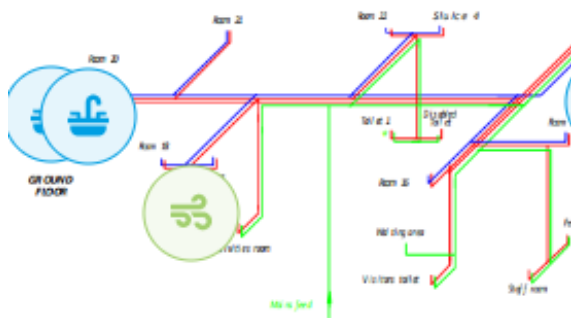
Remote monitoring was then installed on the system (and mapped onto the schematic drawing – example snapshot below)

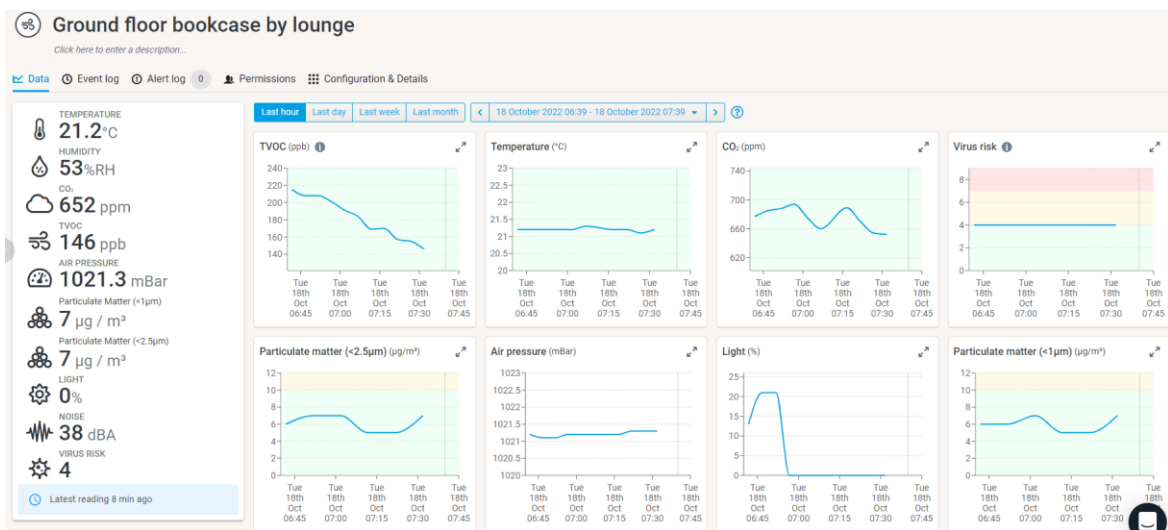
See below screenshot of the aspects being monitored on the air monitoring system (noise and humidity are also graphed but this is out of the screen shot).

The previous graph is set to an hour, however altering the widget to go over the last week indicates the CO2 level at points exceeded 1400ppm, far exceeding 1000ppm on four separate occasions.

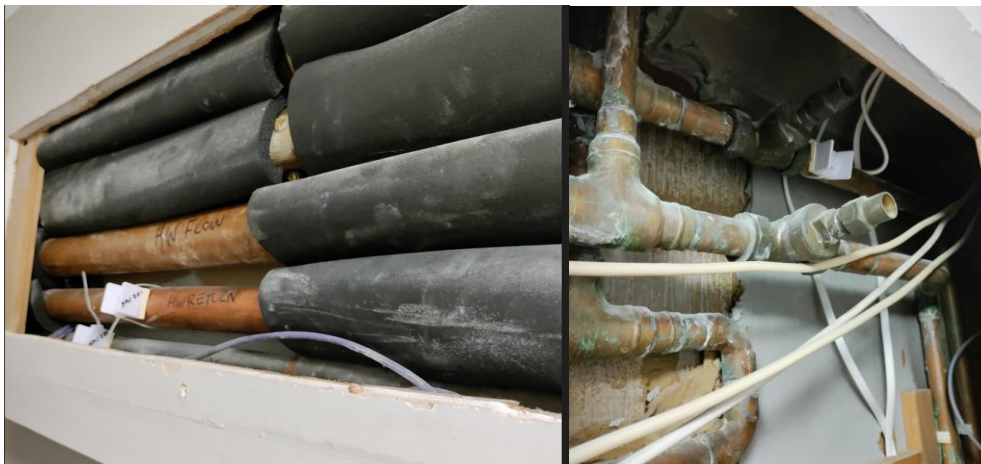
Where possible the intention of the monitoring on the hot water system was to install the probes at the hot water recirculation on site. See below imagery for where the installations were made in both the recirculation pipework by room 1, and the main recirculation pipework void by room 11.

The recirculation pipework temperatures are below, first for the corridor outside room 11 and then also the pipework monitored in the second picture near room 1 (next page). The temperatures in the main pipework run appear to be reaching 55, however they are not staying above this level. The probe by room 1 shows temperatures well below this.
